DEPARTMENT OF NATURAL RESOURCES
DIVISION OF OIL, GAS AND MINING

RE: Site Visit, Cameron #1 Project, Native Asphalt Company, S/047/036,
Uintah County, Utah

Date of Inspection: October 10, 1990

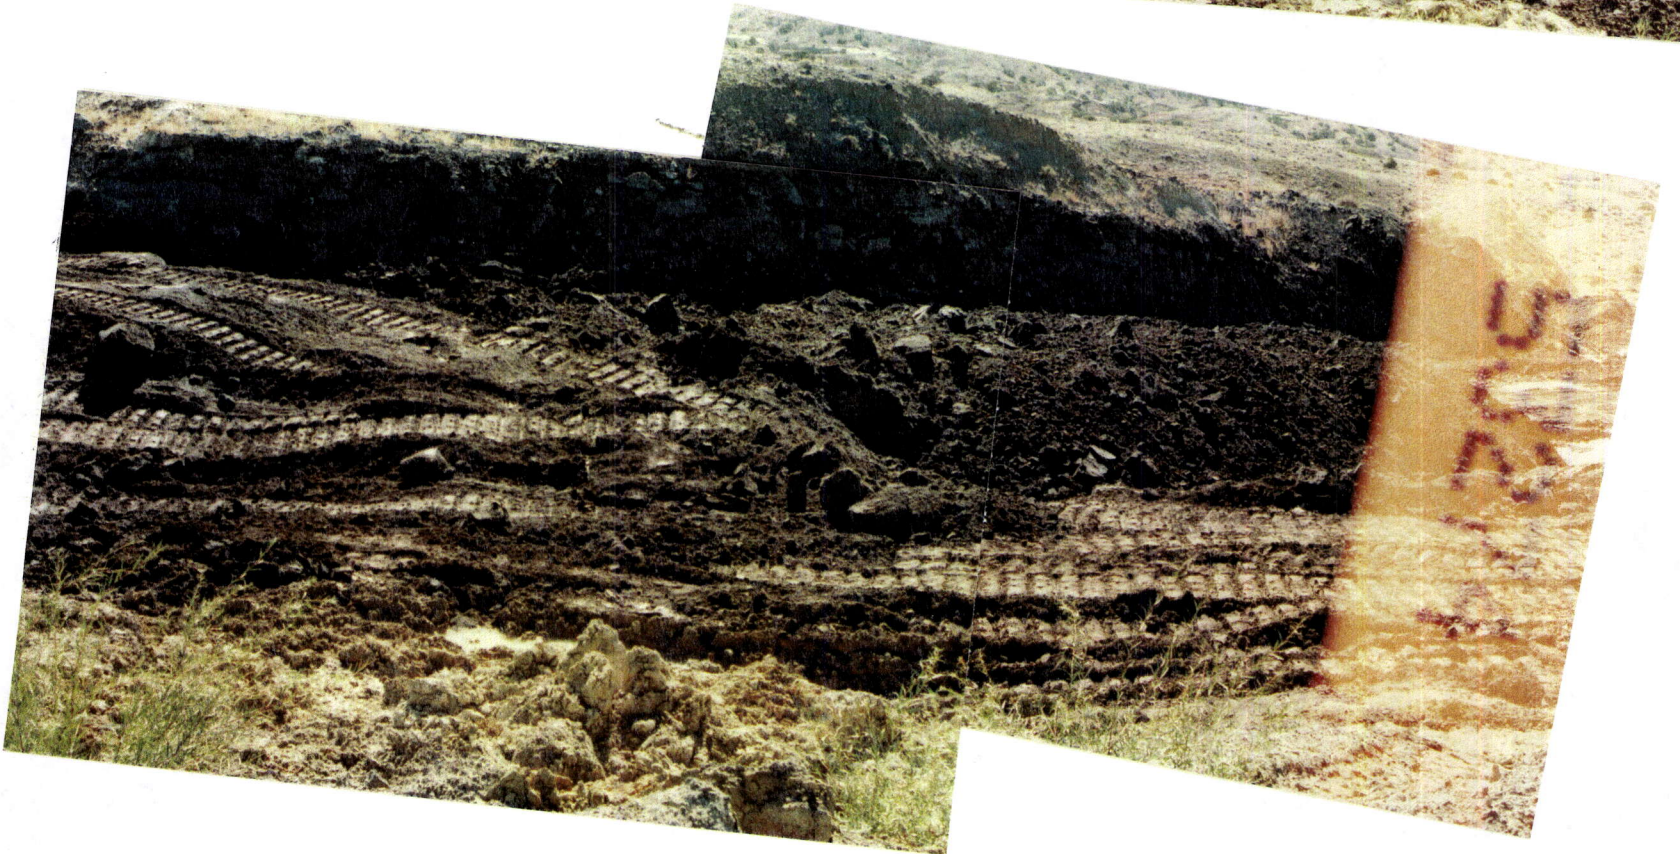
NATIVE ASPHALT CO. S/047/036
10-10-90

The pit was draining water from the associated wetland area. Groundwater had, over a short time, seeped into the pit, eventually filling it and creating a poor quality discharge. The operator has constructed a temporary diversion at the toe of the seep which is now channeling the majority of water away from the pit. It was agreed, during our meeting, that keeping groundwater away from the pit is the primary environmental concern at this site.

DETAIL OF CURRENT ASPHALT PIT

- NOTE SEEPAGE DIVERTED TO LEFT

& PIT DRAINAGE DIVERTED TO THE RIGHT

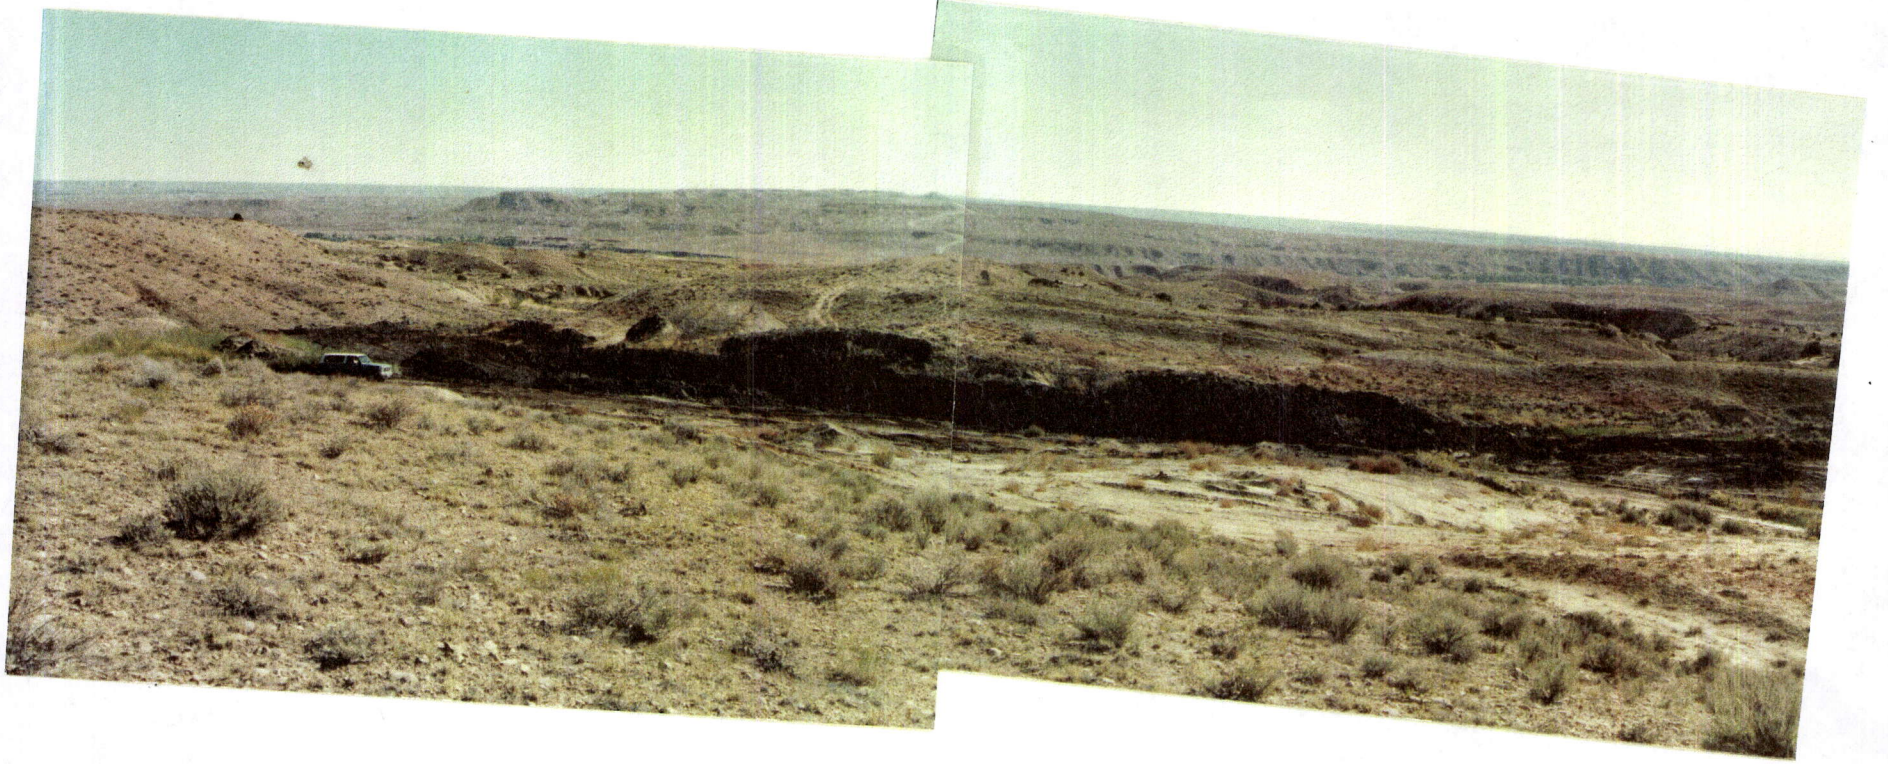
Camron Flair
S/047/003

A sample (oil and grease) of pit discharge water was taken during this inspection. Also, we observed that some type of micro organism was re-colonizing areas in the stream channel containing pit discharge water. This organism appears to feed off the oils dissolved in the water. During our last inspection, this bug colonized most of the bottom of the stream channel creating a thick dark brown, yellow slime.

Discharge from pit showing bugs in water
and microbial colony forming.

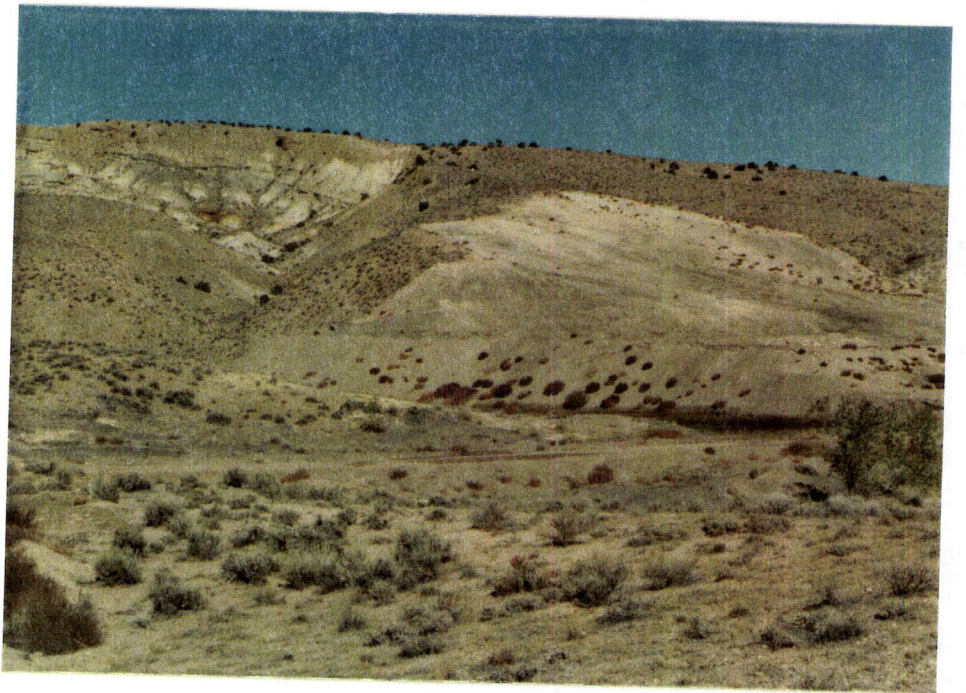
Cameron #1 Mine
S/043/036

After an evaluation of the site, by Kathy Trott of the Army Corp of Engineers, it was determined that the site does fit within the Corp's definition of a jurisdictional wetland, and must be permitted. Wetlands are determined on the basis of depth to groundwater, indigenous plants, soil properties, wildlife and age. Permitting will entail addressing the impacts to the wetland by mining. If the operator keeps to the current mine plan, the wetland area will be further impacted. The operator will probably be asked to create another wetland to replace the one currently being impacted.

Pit excavated in wetlands area

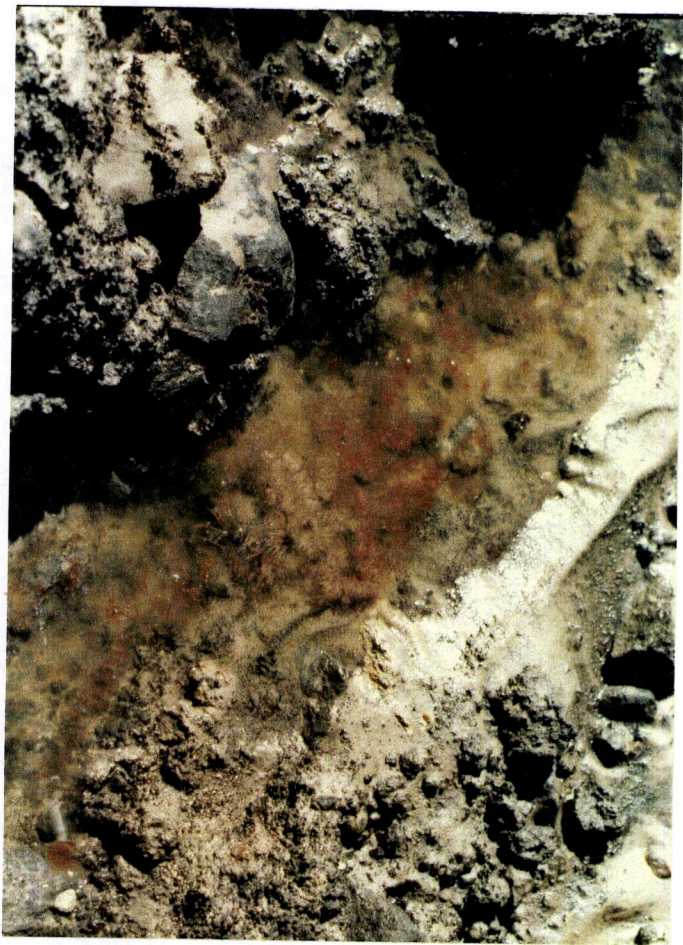
Cameron #1 Mine
S/047/036

Discharge diversion from towards pit
showing microbial populations forming
in channel. Feeding on oils

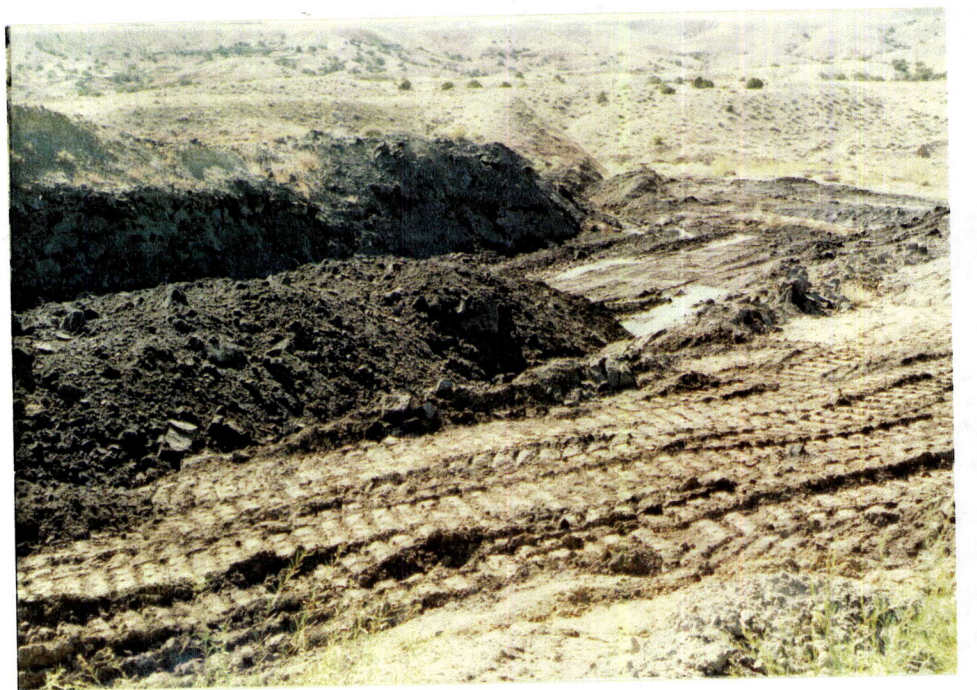
Cameron Mine
S/047/036

Sealed portion of mine. Material
excavated sand & gravel

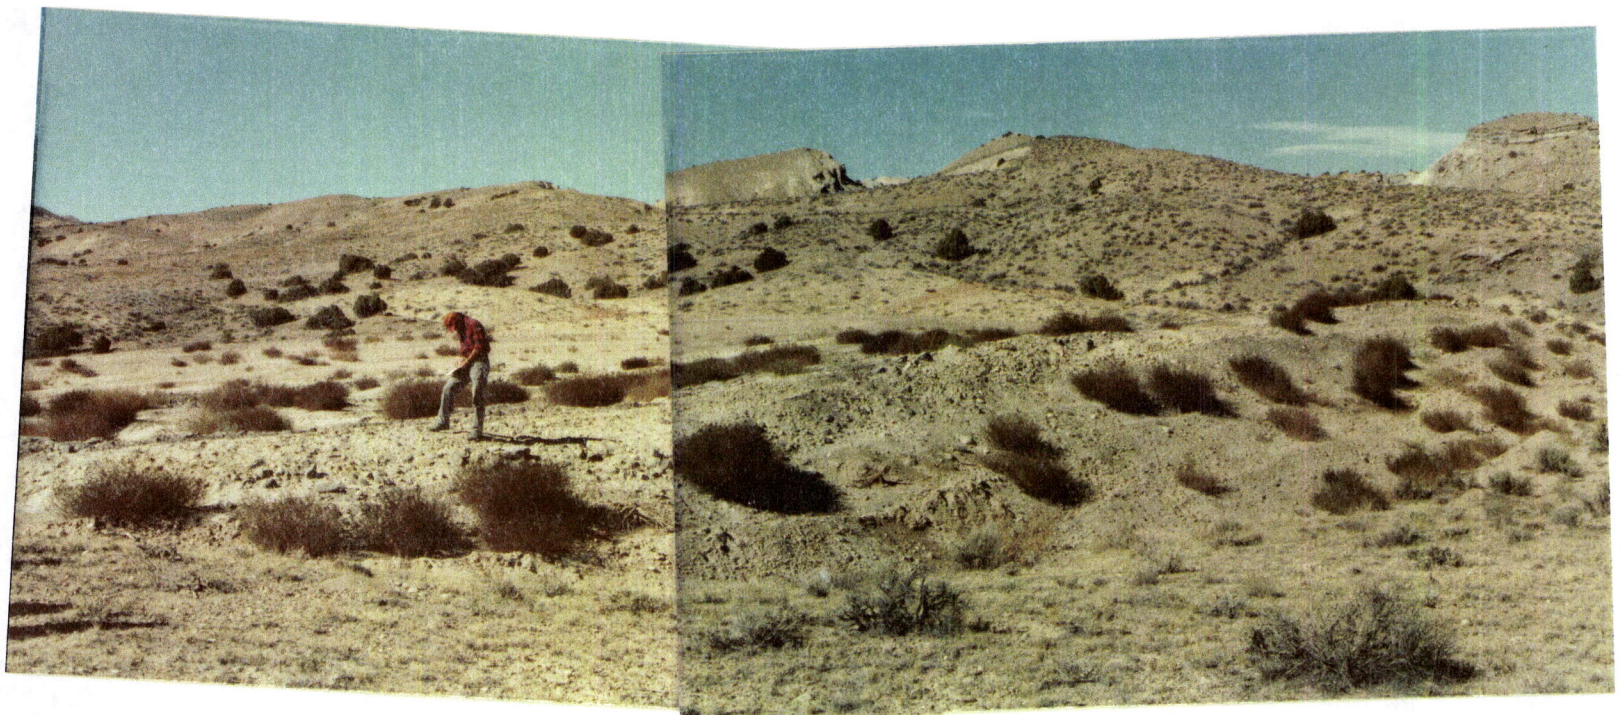
Cameron Mine
S/047/036

The operator's pit has been a focus of concern. It filled up with water this summer and was discharging water of degraded quality. The pit water was absorbing oils from the residual tar sands. The pit has since been drained and was empty during this last inspection.

Mine pit, water drained out recently.
Had been full previous month
